## REPORT OF MARINE SURVEY OF THE VESSEL

1982 Hunter 37

May 8, 2008

Jerry Richter, S.A., Surveyor

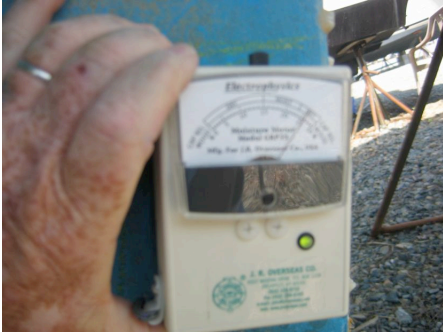
**Sounding and Moisture Readings:** Hull above and below the waterline showed no "wet" readings on a GRP-33 moisture meter except for a 6" square area on the trailing edge of the keel stub on the port side.

**\*C3. High moisture detected in trailing edge of keel stub port side.**

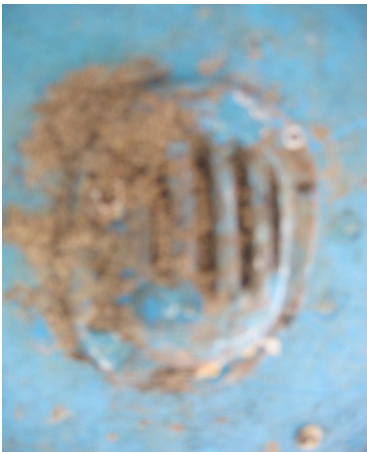
**Thru Hulls:** See Section K and Appendix for listing and diagram of thru hull locations. All appear serviceable except raw water intake screen that is fouled.

**\*A1. Raw water intake clogged with growth.**

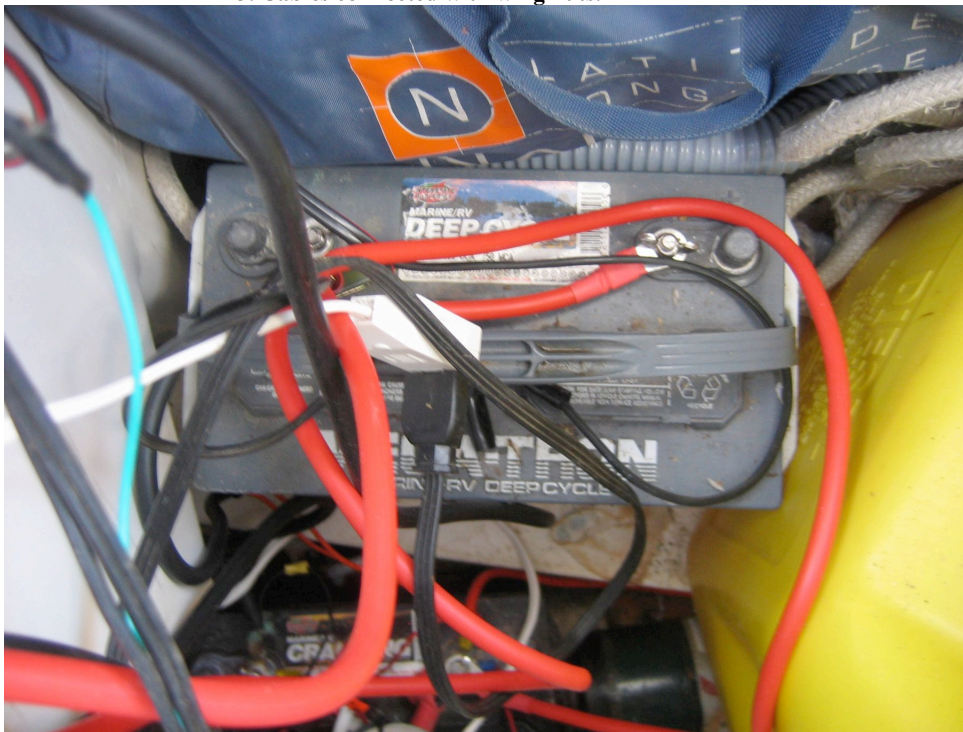
Batteries are located in the starboard cockpit locker. The installation is in violation of several CFR requirements and ABYC Standards. They are not secured, terminals are not covered, and cables are connected with wing nuts vice nuts, and are not contained in an acid proof box. The batteries are also stored below unsecured electrical components (automotive quality inverter, battery charger/starter). The specific requirements of 33 CFR 183.420 (a), (b), and (d) and Section 10.7 of ABYC Standards apply

**\*A6. Battery terminals not protected from contact.**

**\*B13. Cables connected with wing nuts.**

*B11. Ice box drain clogged.	Clear drain
*B12. Sound insulation on engine room access panels badly deteriorated.	Renew insulation
*B13. Cables connected with wing nuts	Replaced with hex nuts
*B14.No overcurrent protection or breaker within 10 feet of shore power connection.	Install breaker within 10 feet before panel
*B15. Anchor rode not serviceable.	Renew anchor rode
*B16. Moisture around all port chain plates and around starboard aft lower. Corrosion visible at deck joint.	Have rigger inspect and repair

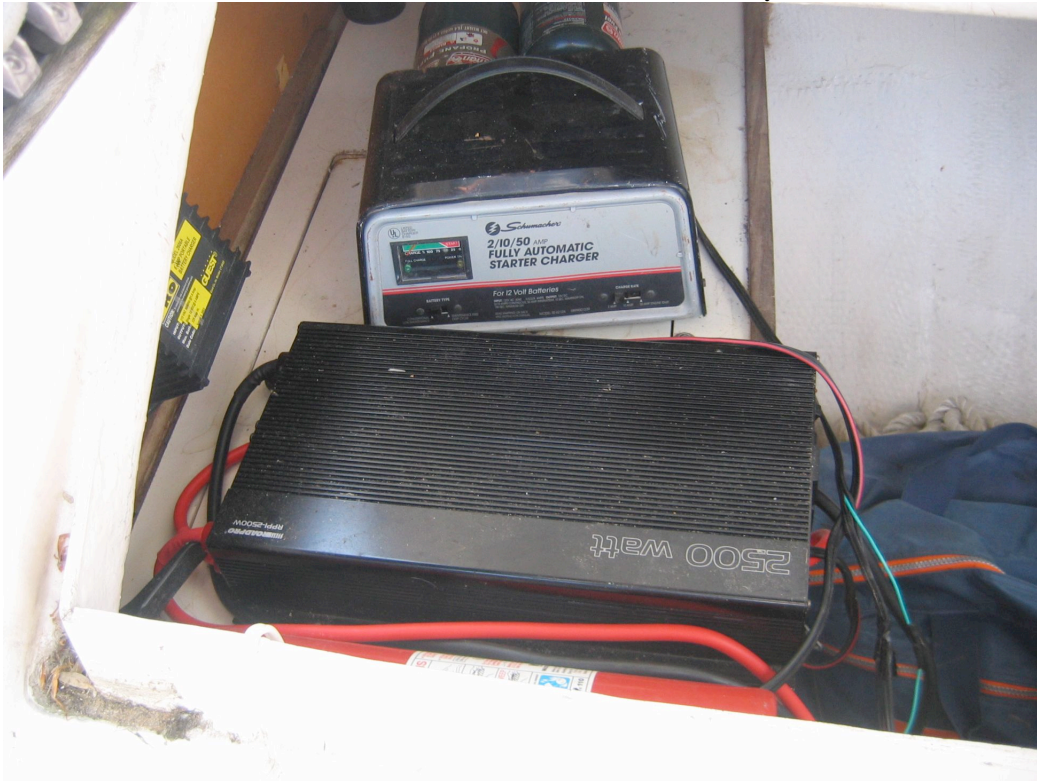
**Inverter:** RoadPro 2500 watt inverter located on shelf in starboard cockpit locker, above batteries, not secured. Poses danger of falling on batteries and shorting unprotected terminals.

**\*A7. Automotive rated inverter unsecured above battery installation.**

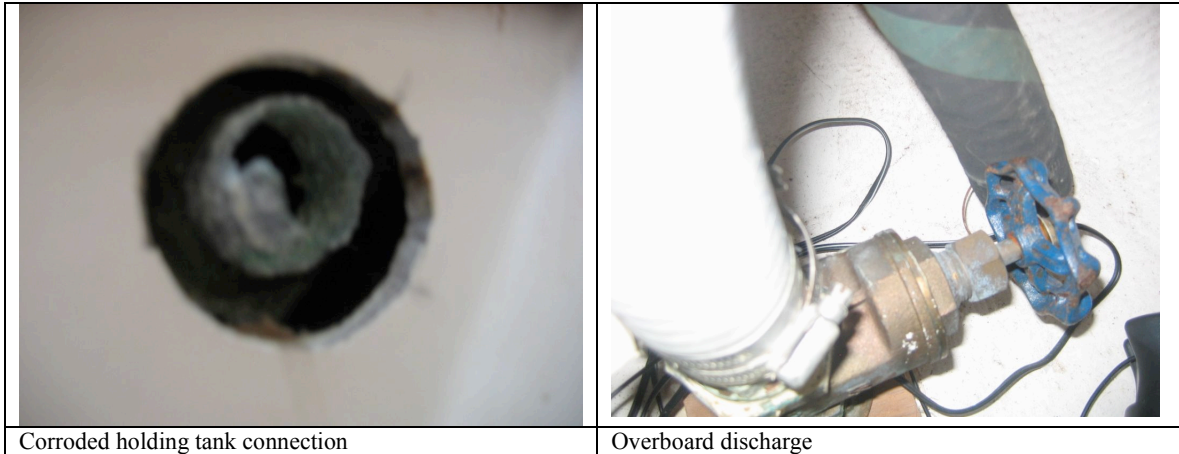
**MSD Type:** Holding tank disconnected. Head plumbed to discharge directly overboard through a gate valve thru hull. Gate valve was open when inspected.

The original equipment waste pump/diverter valve has been disconnected, as has the pump out line. Direct connection to overboard discharge could result in severe penalties if the Coast Guard or other maritime law enforcement agencies ever inspect vessel. An MSD (holding tank) is required on all vessels having and "installed toilet" (33 CFR 159.7). An alternative to installing an new holding tank is to remove the toilet and use a Porta Pottie type device.

**\*A9. Head plumbed to direct overboard discharge.**

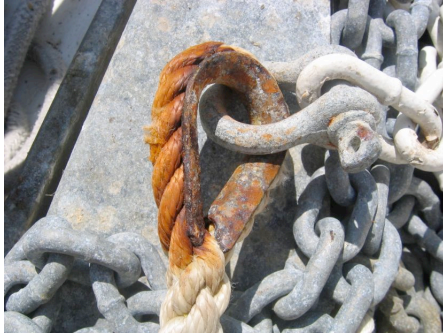
Thimble badly corroded

Splices deteriorating  
Safety Wire not installed on shackles.

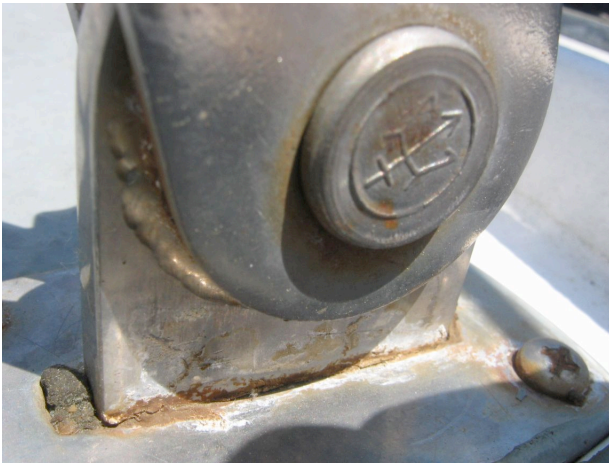
**Turnbuckles:****Type (closed/open)** Open**Play** None**Cotter Pin** Properly installed**Thread status** Good, room remaining for adjustment**Condition** Serviceable**NOTE: Turnbuckles and chainplates were not inspected with penetrant dye.****Tangs:** Not inspected from deck level**Chain Plates:****Backing Plates** Stainless steel backing plates on tabbed bulkheads**Stress Cracks** None observed**Corrosion** Corrosion noted at deck penetration. There was also high moisture level noted in deck around all port side chain plates and on the starboard aft lower chain plate. May be crevice corrosion in chain plates where they pass through the deck.**\*B16. Moisture around all port chain plates and around starboard aft lower. Corrosion visible at deck joint.**
